Manhole Inspection Summary

Manhole # S27E__053MH

Location Address: **754 DR BENJAMIN QUARLES PL**

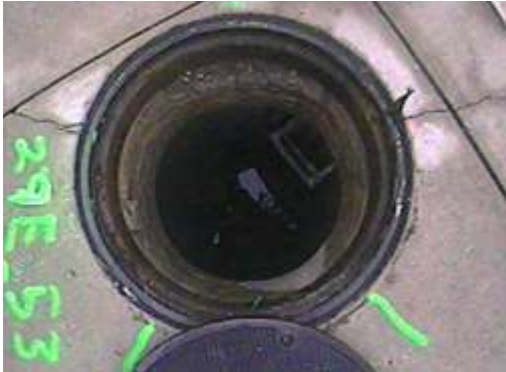
Defect 1

Offset: **3** (in.)

FRAME OFFSET

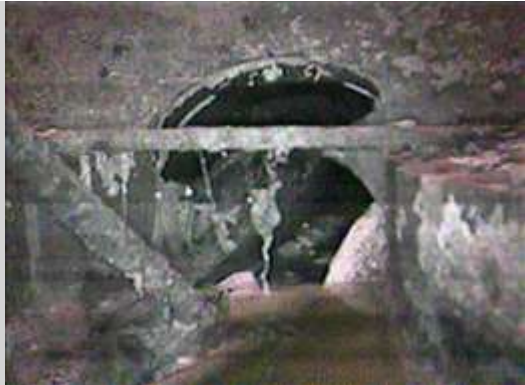
12 O'Clock Outflow

8 in. Circular Gravity Sewer
Pipe Out @ 12 O'Clock

Pipe Height: (in.) Direct
Pipe Material: **PVC** ☐ Pipe Lined
Invert Depth: **15.20** (ft.) Flow Characteristics: **Slow**
Deposits: ☒ None ☐ Mud ☐ Sludge ☐ Debris ☐ Grease
Silt Depth: (in.) Deposits Extent:
Infiltration: **None** Pipe Seal Cond: **Sound**

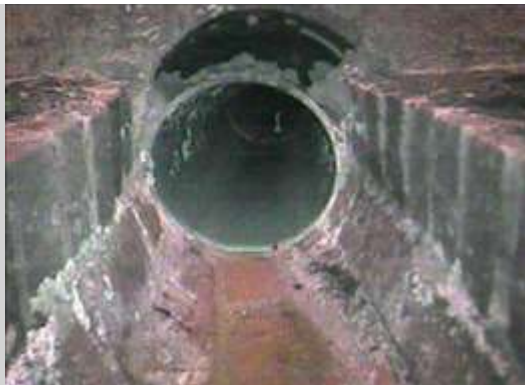
5 O'Clock Inflow

8 in. Circular Gravity Sewer
Pipe In @ 5 O'Clock

Pipe Height: (in.) Direct
Pipe Material: **PVC** ☐ Pipe Lined
Invert Depth: **15.05** (ft.) Flow Characteristics: **Slow**
Deposits: ☒ None ☐ Mud ☐ Sludge ☐ Debris ☐ Grease
Silt Depth: (in.) Deposits Extent:
Infiltration: **None** Pipe Seal Cond: **Sound**

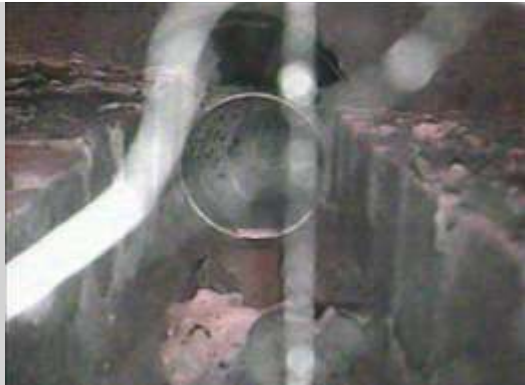
8 O'Clock Inflow

6 in. Circular Gravity Sewer

Pipe In @ 8 O'Clock

Infiltration: **None**

Pipe Seal Cond: **Sound**
